Miami Air International  
Jacksonville, Florida  
May 3, 2019  
DCA19MA143

MIAMI AIRLINES, B737-81Q, EMERGENCY EVACUATION IN RIVER, FWD RH & LH  
DOOR SLIDE UNSUCCESSFUL DEPLOYMENT

## Field Investigation Report

**SUBJECT: Miami Air International, B737-81Q, Emergency Evacuation in River, FWD RH & LH Door Slide Unsuccessful Deployment**

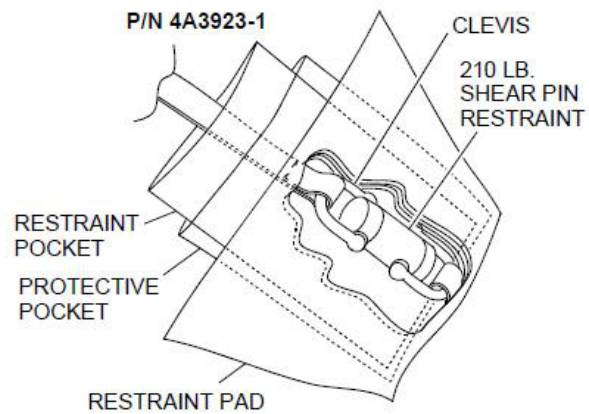
- (a) The secondary restraint (P/N 4A3613-210, 210 lb. shear pin restraint) was not connected (refer to Figure 5A, 5B, and 5C). This secondary restraint should be installed as shown in figure 5D (see instruction (4) on page 7052 and figure 7041 on the page 7053 of CMM 25-60-37 Vol.2). When correctly installed, the restraint separates into two pieces during the slide deployment. Figure 5B shows the restraint at that anchor point and no portion of the restraint shown in anchor point inside the restraint pad, see Figure 5C. This evidence indicates that the restraint was not installed at the anchor point inside the restraint pad and would not result in the restraint breaking as intended during a deployment. Properly installed restraints allow the inflatable sections to inflate sequentially and deploy in a controlled manner.

**Figure 5D: Secondary restraint properly installed**  
(Figure 7041 on page 7053 of CMM 25-60-37 Vol.2)

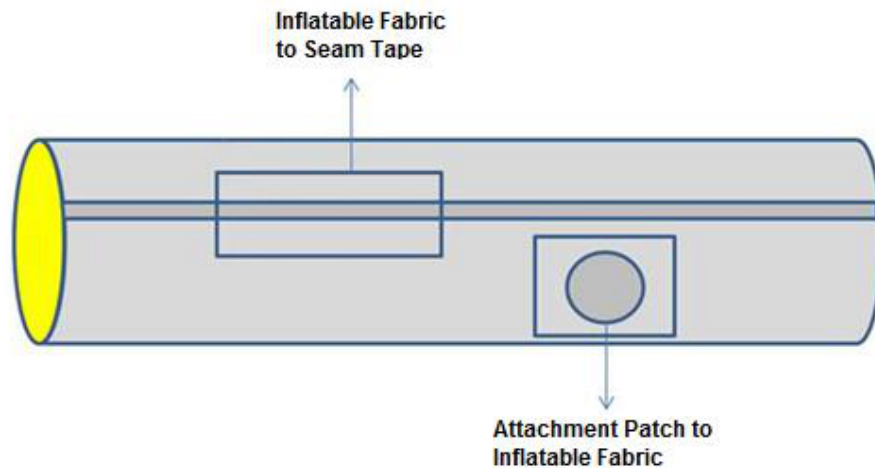
The seam separation of head end tube appears to be exhibiting an adhesive bond failure. To support further investigation, the slide was cut into sections. The following representative sections were tested to determine seam and attachment strength integrity from inflatable (refer Figure 7).

**Figure 7: Inflatable Section Schematic**

Seam peel adhesion strength testing is conducted on the seams where at the location of the rupture as well as seams located from other areas of the slide (BNG1781). Trapezoidal tear strength and grab tensile strength testing was also conducted on the fabric from both sides of the slide (refer Table 3).
